# LEARNING FROM THE AFTERMATH

Was icing to blame — or something as simple as a checklist item?  
BY ROGER PELLETIER

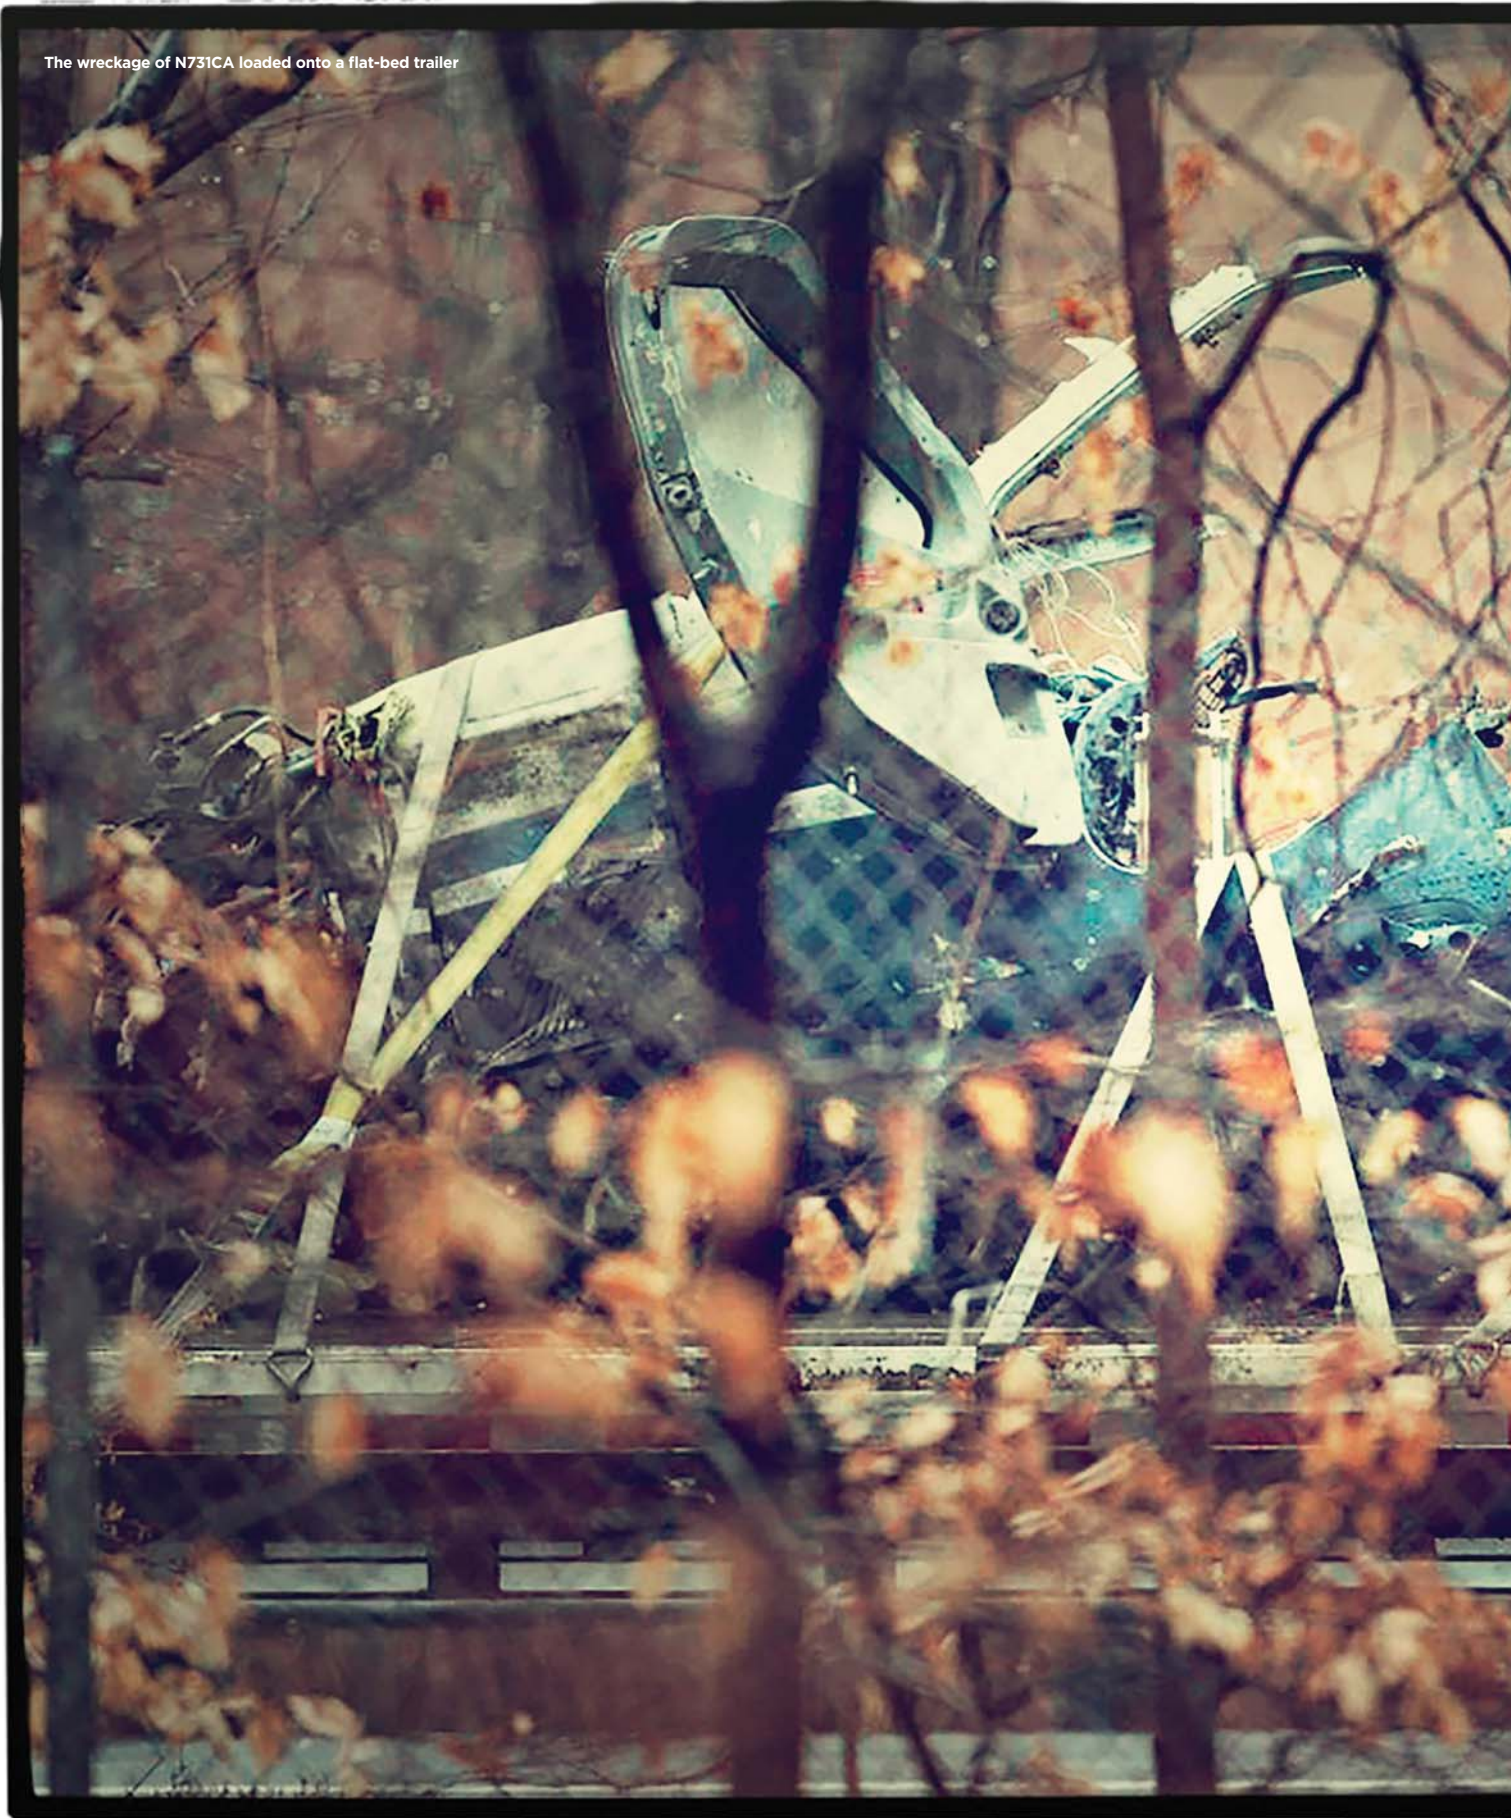
The wreckage of N731CA loaded onto a flat-bed trailer

Assuming this plane picked up inches of ice within a few minutes and stalled, why was no ice reported on any part of the airframe on the ground, even though people were at the accident site within minutes? Not one witness statement in the NTSB

files reports ice on any structural parts. **[See Image A]** It is very common in the case of airframe icing accidents for people on the ground to report ice on the wings or tail parts flung from the main body of the plane and not subject to fire.

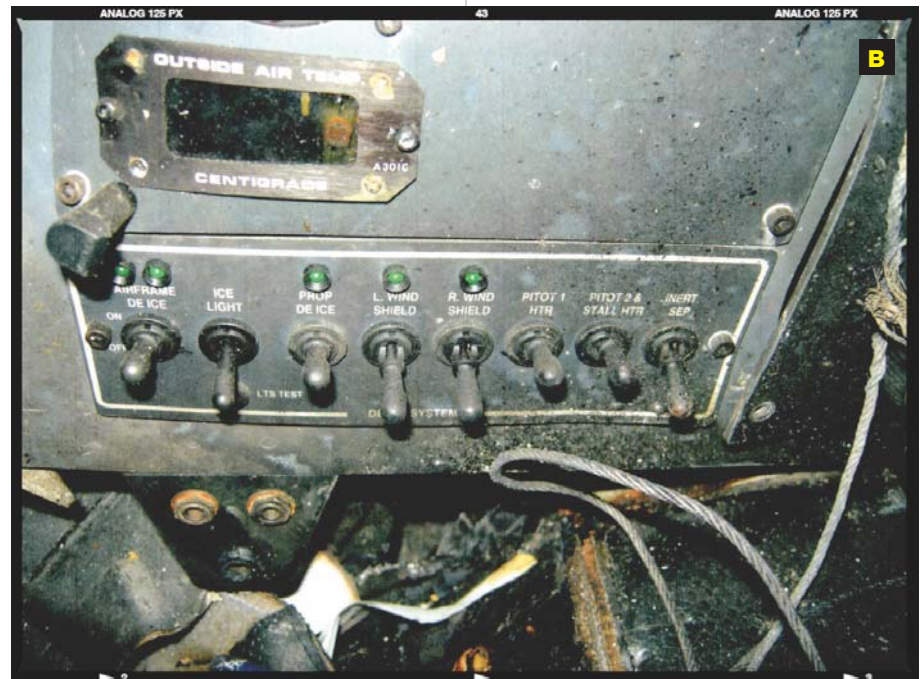
The NTSB report itself documents that the Inertial Separator, common on most turboprop airplanes, sometimes called "ice vane," was in the OFF position. **[See Image B]** The NTSB report, however, does not comment on the implications of this fact at all! This was not the scent trail it was on. The report cites a passage from the POH that warns of "flight into severe ice." Since this is true for almost all aircraft, it is not much of a causal explanation. The documentation of the separator switch, however, does point the direction in which to look.

position and does mention that the POH requires the separator be in the ON position when entering IMC with possible ice formation. The video even states that it may explain the pilot's use of the word "rattle" as the possible sound of engine ice ingestion. This is very likely, since it is not a sound I have heard other TBM pilots describe before the aircraft stalls. If N731CA were about to stall because of structural icing accumulation, I do not see how it would "rattle." The video, however, does not follow up on the implications of the separator not being ON.
