# LEARNING FROM THE AFTERMATH

Was icing to blame — or something as simple as a checklist item?  
BY ROGER PELLETIER

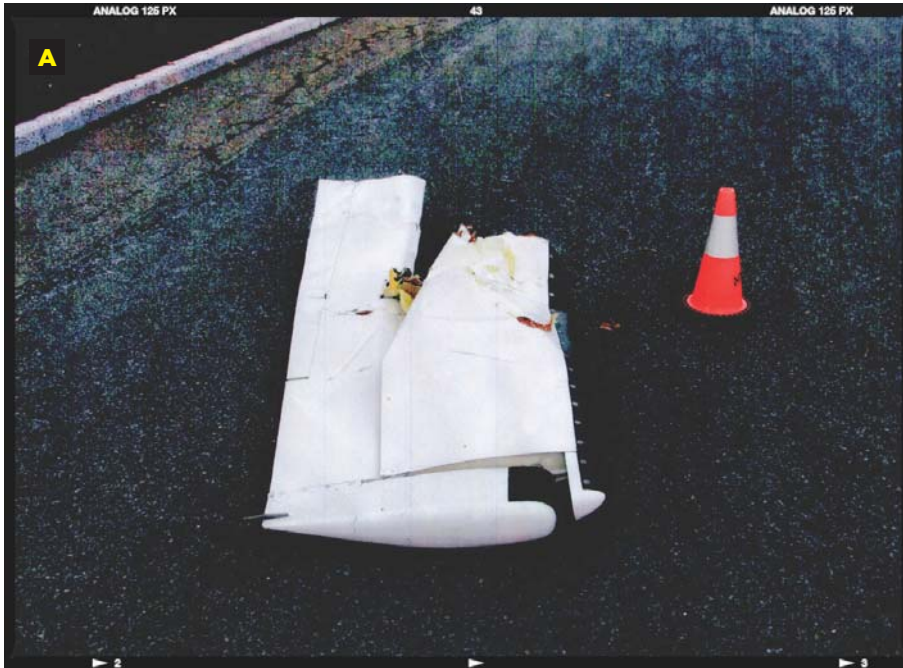
Assuming this plane picked up inches of ice within a few minutes and stalled, why was no ice reported on any part of the airframe on the ground, even though people were at the accident site within minutes? Not one witness statement in the NTSB

files reports ice on any structural parts. **[See Image A]** It is very common in the case of airframe icing accidents for people on the ground to report ice on the wings or tail parts flung from the main body of the plane and not subject to fire.

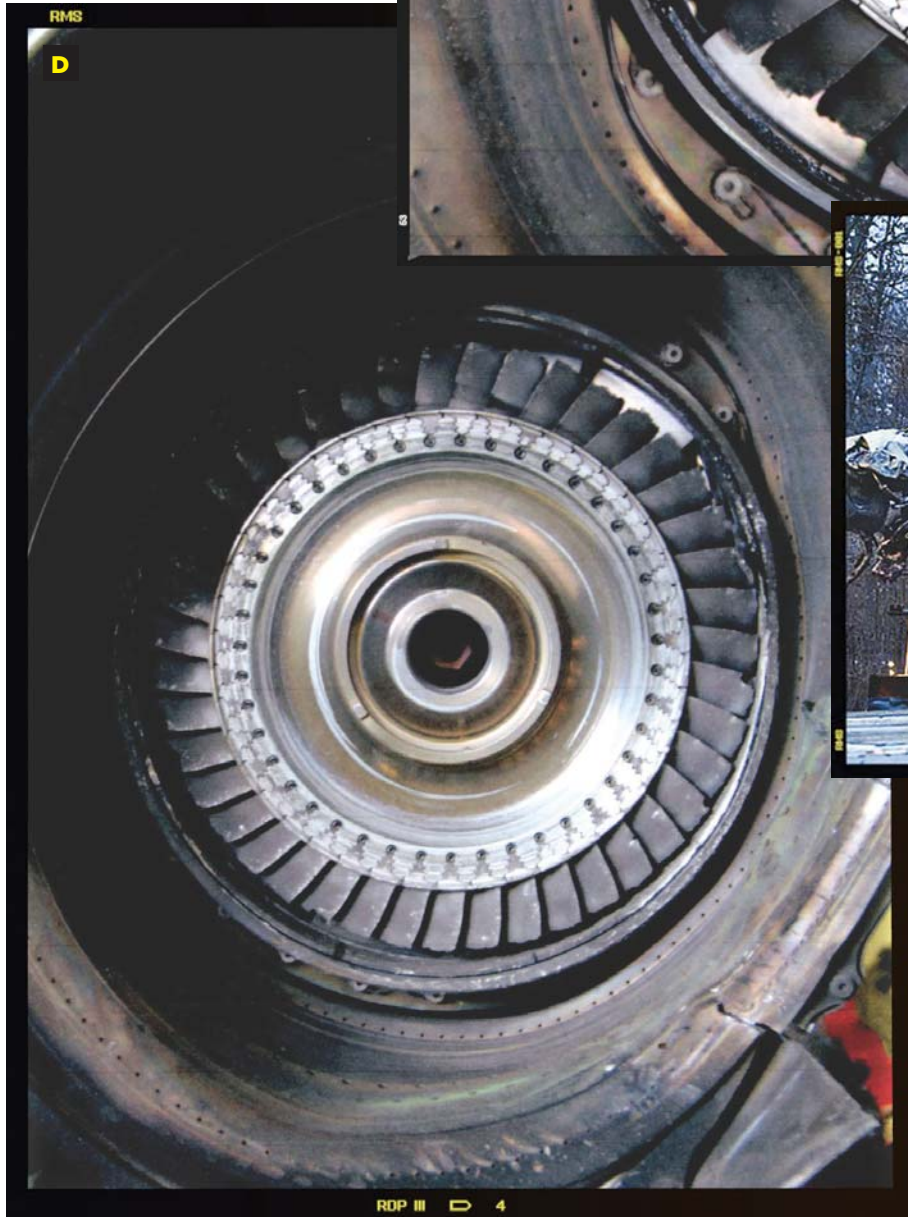
ists for this in the NTSB picture of the compressor blades. **[See Image C & D on next page]**

This blade damage, in a disagreement with the NTSB report on this point, seems to me to match blades I've seen that have had ice FOD damage! A turbine mechanic,

when shown the picture of these engine compressor blades, agrees that this engine ingested something to cause such damage. Notice how the blade tips are unevenly chewed up and gouged. If the damage had been caused by impact with the ground, you would expect the blades to

be more evenly bent or broken off. A picture of the complete compressor wheel shows very little, if any impact damage that deformed the compressor wheel. How did this damage happen if not from ice ingestion damage?
